MISSISSIPPI ENVIRONMENTAL GEOLOGY

David T. Dockery III and David E. Thompson

Mississippi Department of Environmental Quality
Office of Geology
Second Edition, 2019

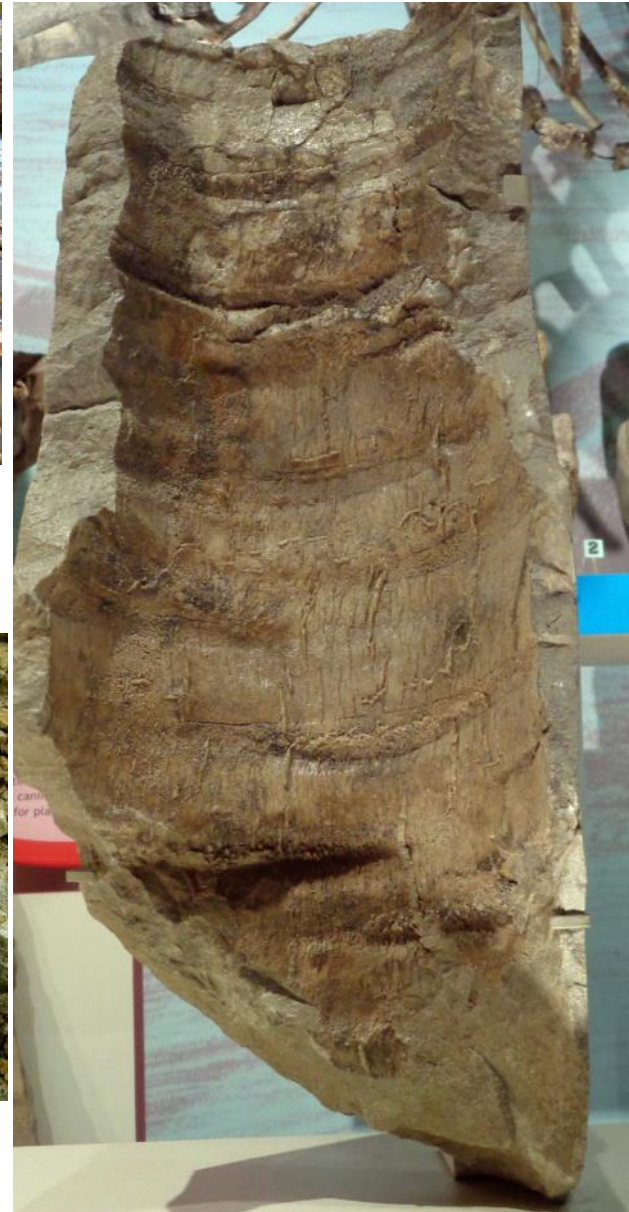
Palm Wood Rankin County
Sp. unknown
impression of trunk's outer surface

Figure 742. Imprint of a palm trunk in Glendon Limestone from the Marquette Cement Manufacturing Company's quarry at Brandon, Mississippi. Image 2631.

the Catahoula Formation (**figures 742-745**) of Late Oligocene to Miocene age, and from the Hattiesburg Formation (**Figure 746**) of Middle Miocene age. Collectively, these occurrences indicate the existence of a coastal palm forest across central Mississippi during Oligocene and Miocene time.

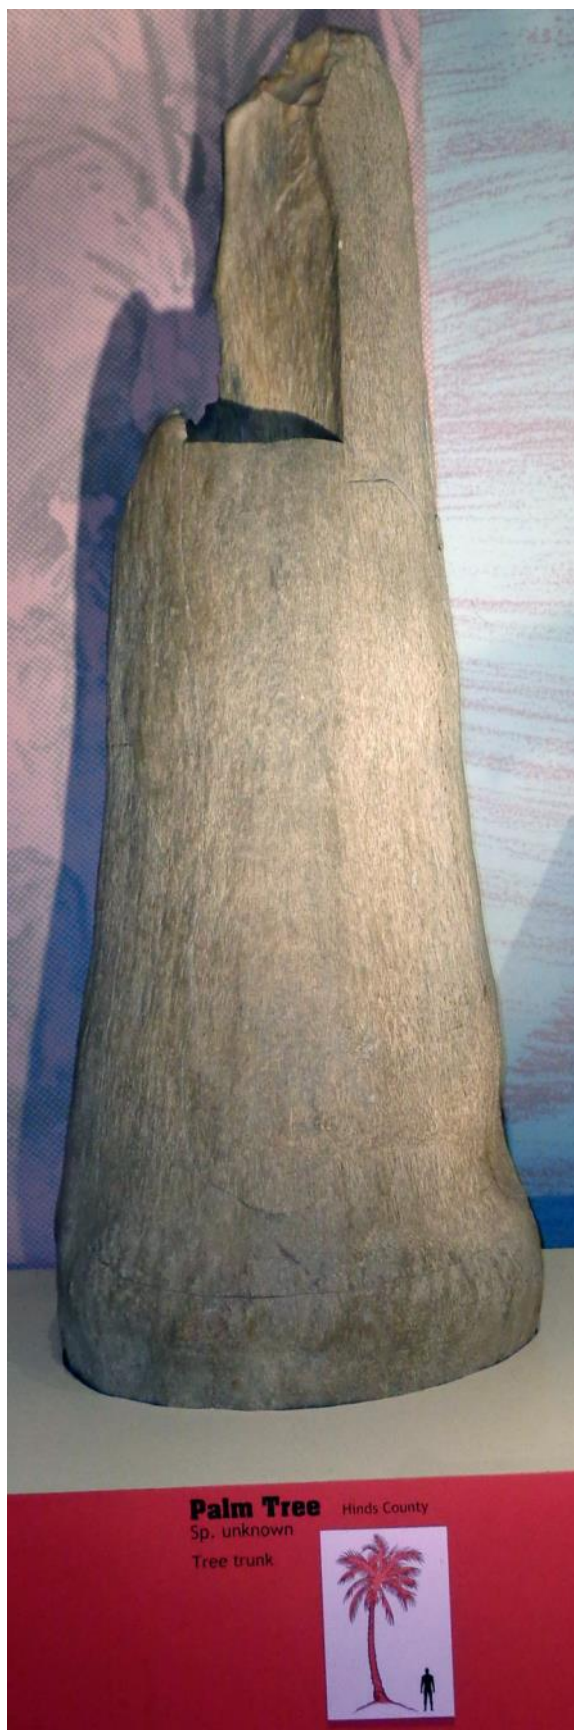
Figure 743. Left; petrified palm trunk of the species *Palmoxydon lacunosum* (Unger in Martius, 1845) from the Catahoula Formation in White Oak Creek in Claiborne County, Mississippi. The trunk is 21.5 inches in diameter at the base, 60 inches long, and weighs 500 pounds. Image 2632.

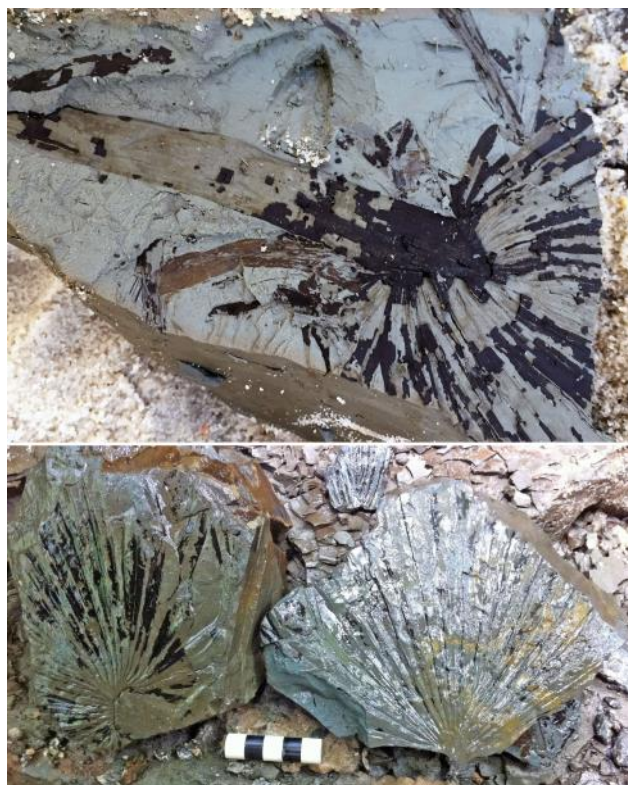
Figure 745. Palm fronds from the basal Catahoula Formation at the Jones Branch Locality in Waynesboro, Mississippi. Pictures by James Starnes taken on July 2, 2014. Images 2634.

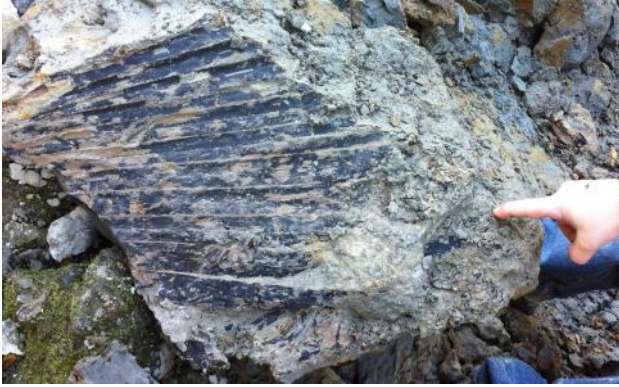
Figure 746. Palm fronds from the Hattiesburg Formation on the Bowie River at Hattiesburg, Mississippi. Picture taken by James Starnes on November 2, 2014. Image 2635.

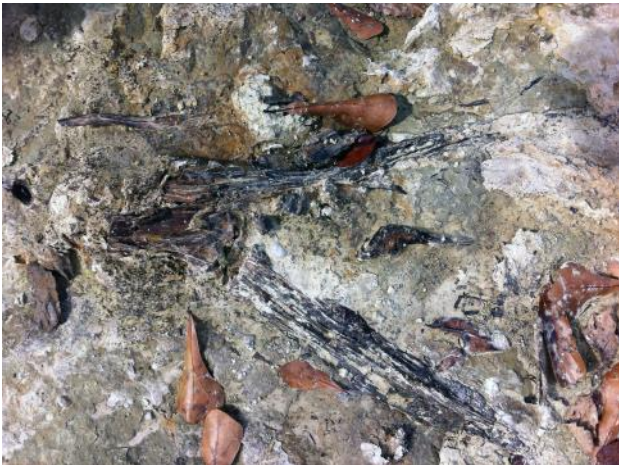
Figure 748. Lignitized White Pine stump and roots in the Graham Ferry Formation on Saucier Creek in Harrison County. Picture was taken by James Starnes on December 10, 2014. Image 2637.

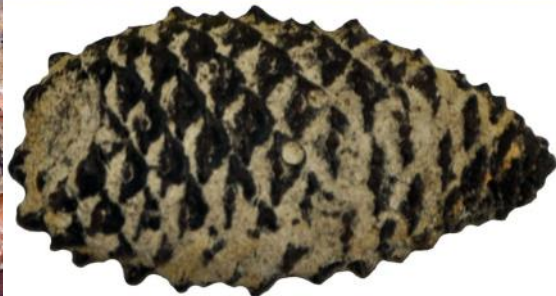
Figure 749. White Pine pinecone from the Graham Ferry Formation on Saucier Creek in Harrison County. Scale in inches. Picture was taken by James Starnes on December 11, 2014. Image 2638.

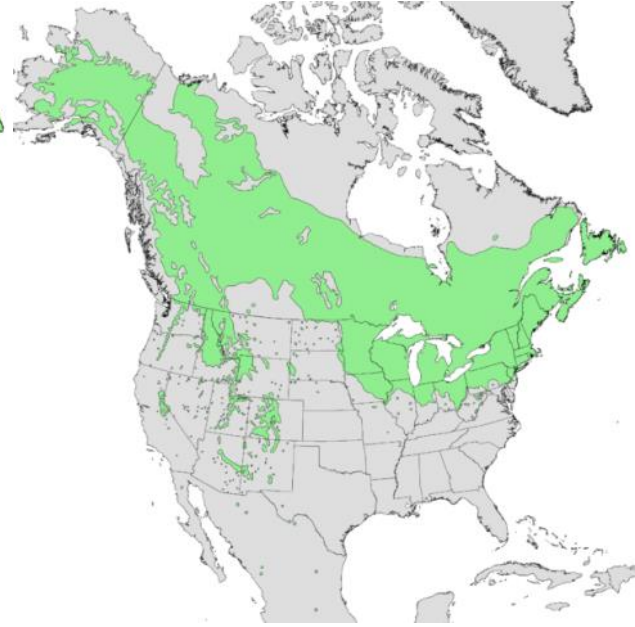
Figure 751. Modern distribution of Spruce in North America, including Red Spruce (*Picea rubens*), Blue Spruce (*Picea pungens*), Black Spruce (*Picea mariana*) White Spruce (*Picea glauca*), and Sitka Spruce (*Picea sitchensis*), from Wikipedia. Image 2640.

Pleistocene Coastal Spruce Forests. **Figure 751** show the range of spruce, *Populus tremuloides*, in North America. Today Spruce trees are found in northern temperate and boreal regions of the continent. Brown (1938) collected the wood and fruit of northern tree species such as white spruce (including entire cones), larch, and white cedar, in association with a tapir molar and mastodon tusk, in the Pleistocene alluvium of streams in Louisiana. Pollen from sedimentary cores drilled in the Pearl River floodplain in association with the proposed Shoccoe Dam Project revealed a change in forest conditions around 9,300 years ago, when Pleistocene boreal forests of spruce were replaced by oak, hickory, and gum (Dunbar and Coulters, 1988; Albertson and Dunbar, 1992). Davis (1983, p. 179) noted a change in the central Gulf Coastal Plain forests at 10,000 years ago from boreal (i.e. spruce) to deciduous species such as oak, sweet gum, and

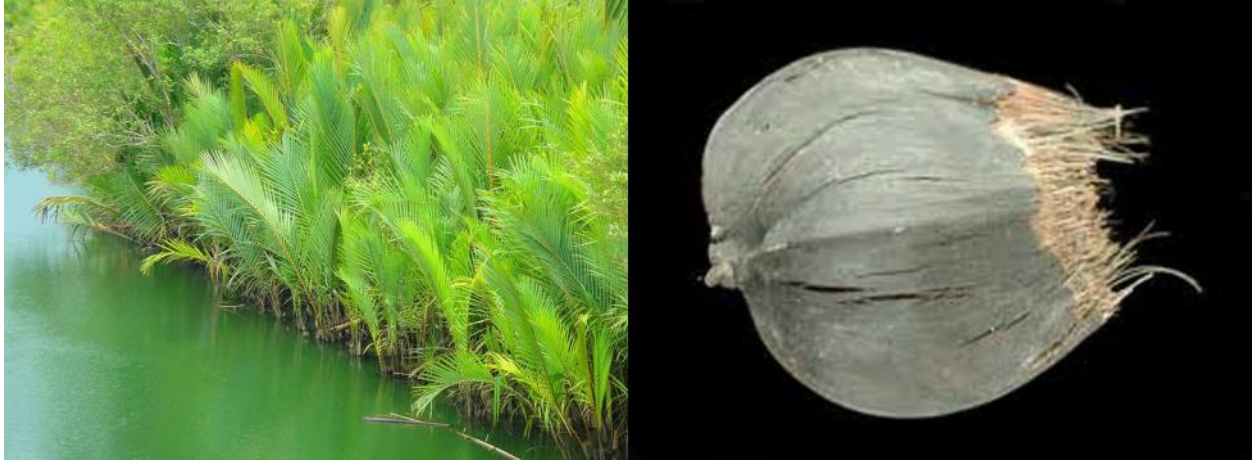
Figure 755. At left, *Nypa fruticans* (*Nypa* palms) growing in a mangrove swamp in Bohol, Philippines; at right, *Nypa fruticans* nut. Image 2242.

struction of Interstate 20. **Figure 755**, at left, shows the modern *Nypa* palm species *Nypa fruticans* growing in a mangrove swamp, and, at right, a *Nypa* palm nut. Fossil *Nypa* nuts are also known from the Middle Eocene sand beds of Branksome, England, and in the London Clay on the Isle of Sheppey, Kent, indicating a much warmer climate in the British Isles at that time.

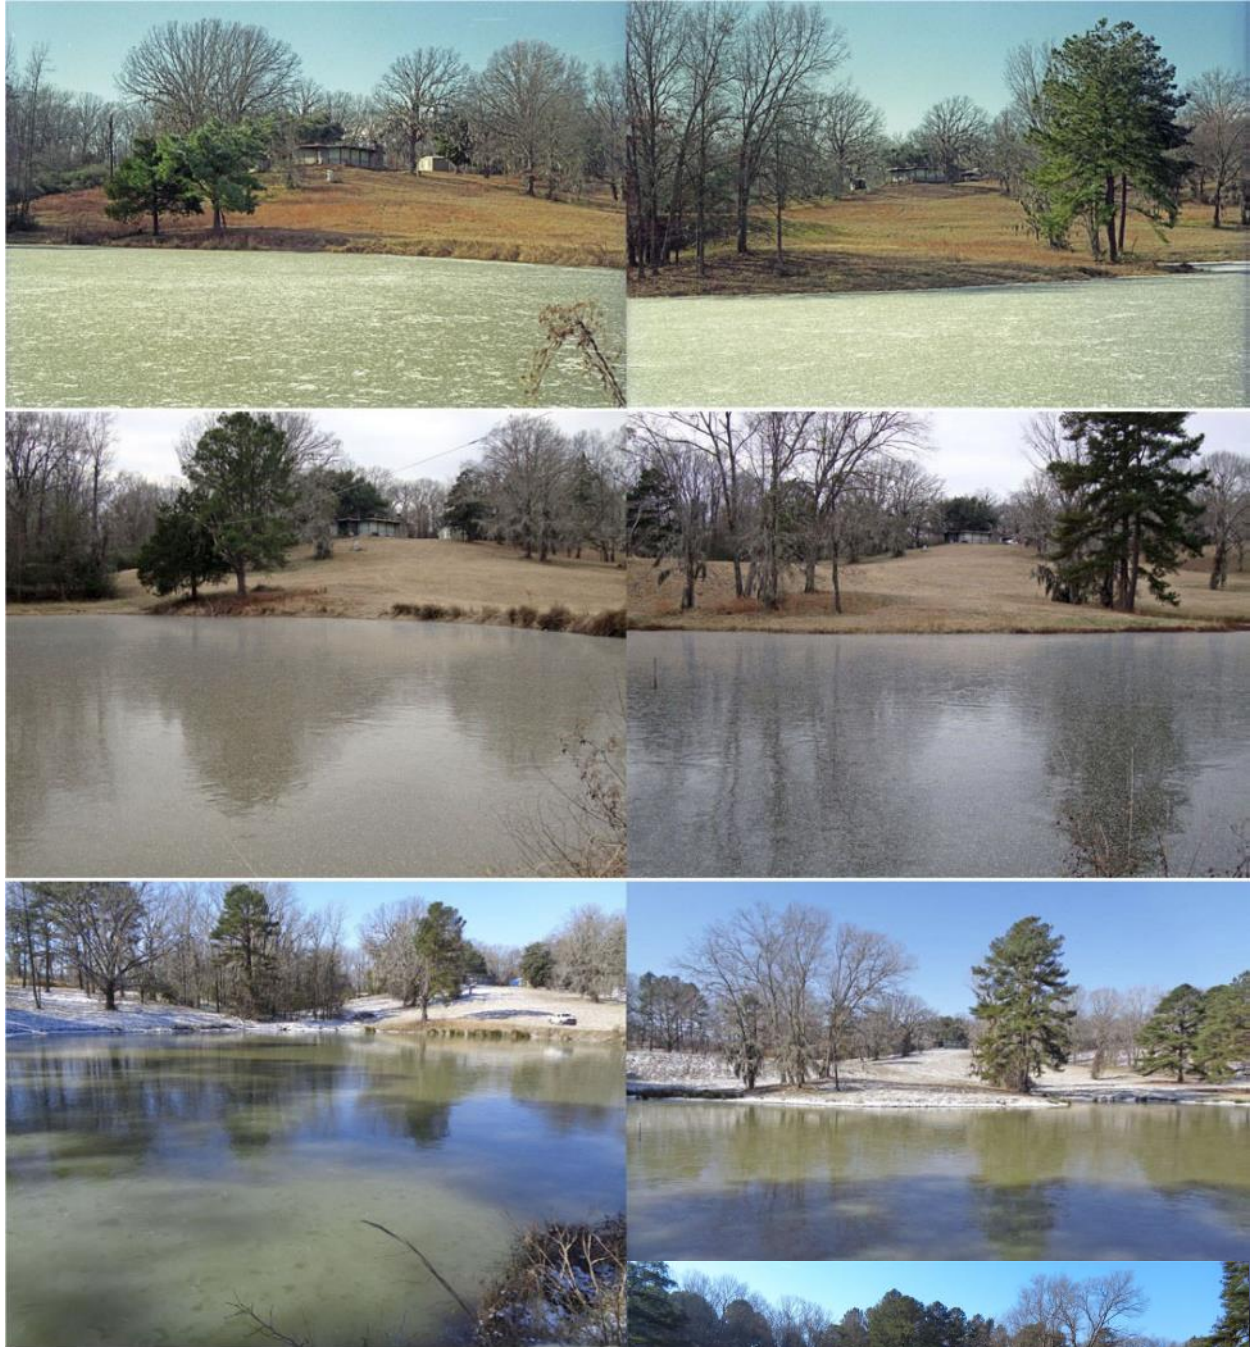
Figure 762. Frozen upper (left) and lower (right) lakes at Mossy Grove in northwestern Hinds County north of Clinton, Mississippi, as photographed on February 5, 1996 (top), January 9, 2010 (middle), and January 17, 2018 (bottom pair). At bottom right is the frozen surface of the lower lake as photographed with the camera on the ice on January 18, 2018.

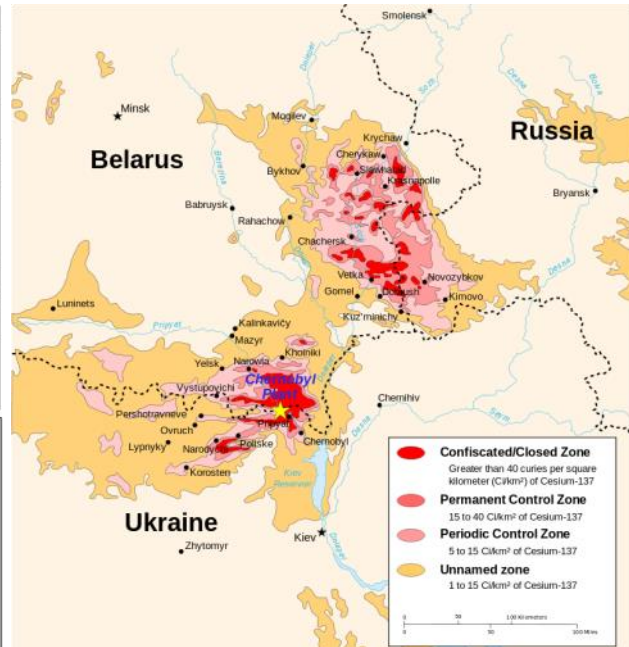
Figure 766. Exclusion zone for the Chernobyl nuclear accident based on the concentration of the radioisotope Cesium-137, from Wikipedia. Image 2648.

Though there have been no serious injuries in this country due exposure to radiation from a nuclear power plant accident, there were two notable nuclear plant disasters at Chernobyl in Ukraine and Fukushima Daiichi in Japan. These disasters have rendered large tracts of land inhabitable and a haunt of radioactive wild animals. The Chernobyl exclusion zone covers parts of three countries (Figure 766). The Daiichi exclusion zone includes several provinces in Japan with the eastern half of the 30 km zone extending into the Pacific Ocean (Figure 767).

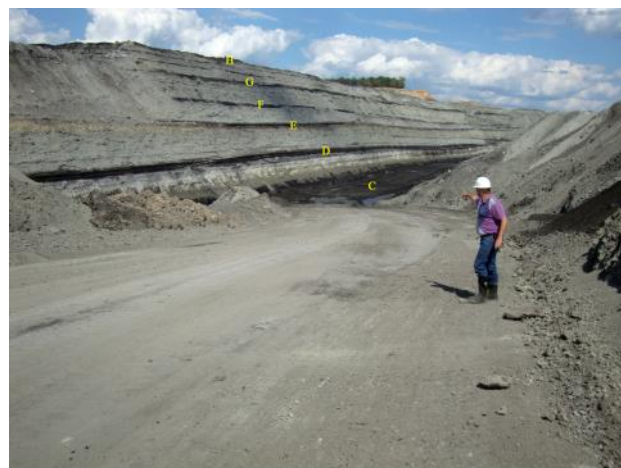
Figure 772. Lignite seams in the Red Hills Lignite Mine as pointed to by James Starnes. Picture was taken on September 29, 2014. Image 2654.

Mississippi Lignite. The use of Mississippi lignite for electric power generation utilizes a local energy resource and protects against market fluctuations in the price of oil and gas. The Red Hills Mine in Choctaw County, Mississippi (Figure 772), produces 3.2 million tons of lignite per year to fuel a 440 megawatt generating plant.
